Post-test Inspection of NASA's Evolutionary Xenon Thruster Long-Duration Test Hardware: Discharge and Neutralizer Cathodes

Rohit Shastry¹ and George C. Soulas²
NASA Glenn Research Center, Cleveland, Ohio, 44135

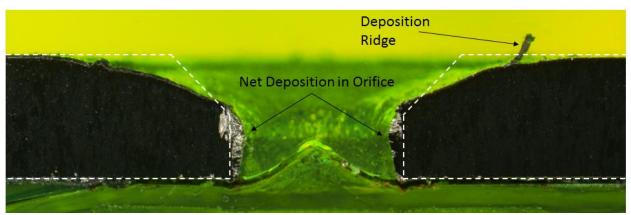
Figure 6. Discharge orifice plate cross section through centerline. The dashed lines correspond to the nominal pretest plate geometry. Net deposition was observed within the upstream orifice barrel.

A non-contact measurement technique performed prior to sectioning indicated that the minimum cathode orifice diameter had decreased by 13% compared to the pretest diameter. In situ measurements taken at the end of the test prior to venting the facility indicated that the orifice diameter reduced by $5 \pm 3.5\%$. The discrepancy, even after accounting for measurement uncertainty, is presently unknown. It is possible the in situ camera for the DCA either did not have the resolution to fully define the cathode orifice edge as it eroded or had insufficient lighting to see through the entire thickness of the plate. A reduction in the minimum cathode orifice diameter was not entirely unexpected, as similar reductions were found during the NEXT 2 kh wear test and NSTAR LDT, measuring 3% and 5% less than pretest diameters, respectively. However, for these tests the source of deposits appear to have come from the keeper and insert. Place 20, 42, 43 The cathode orifice chamfer diameter was also measured with in situ cameras throughout the test. However, as seen in Fig. 6, the outer edge of the chamfer is no longer well-defined. Comparison of in situ images to those taken during the post-test inspection indicate that the boundary being tracked as the chamfer diameter later in the test was likely the inner edge of the deposition ridge. Place 22

Based on Figs. 5 and 6, the deposition ridge is positioned within the eroded zone, and not on the outside perimeter. This indicates that the deposition ridge had formed on the cathode surface after the substrate had eroded, at least to a degree. There also appears to be an inflection point in the eroded chamfer of the cathode orifice plate in the vicinity of the deposition ridge, possibly caused by the deposition shadowing the orifice plate at larger radii, preventing further erosion. This provides insight into the way this deposition developed, which is believed to be responsible for the observed cathode-to-keeper electrical short during the test. This topic is discussed in more detail in Section IV-A-4.

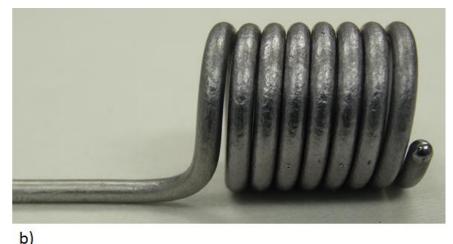
Figure 9. Photographs of a) the DCA heater radiation shield and b) the heater coil after removal from the cathode tube. No visible wear or defects were found to be caused by cathode operation.

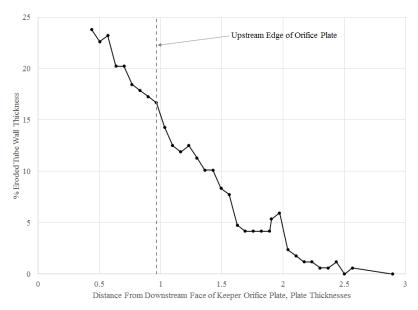
Based on the measurements at the furthest downstream location, approximately 24% of the tube wall thickness had been eroded by the end of the test. However, these measurements were taken in the area of the weld between the orifice plate and the tube, which is downstream of the cathode orifice plate and heater. Upstream of the keeper orifice plate, the maximum eroded depth was approximately 17% of the pretest tube thickness, with erosion observed up to 2.5 plate thicknesses upstream of the downstream face of the keeper orifice plate. By comparison, the maximum erosion observed during the NEXT 2 kh wear test was 7.5% of the pretest tube thickness, with erosion observed up to 6.7 plate thicknesses upstream. Thus, there is a significant reduction in the extent of erosion observed in the NEXT LDT. The primary factor responsible for this difference is likely the reduced beam extraction diameter between the engineering model optics (used in the NEXT 2 kh wear test) and prototype model optics (used in the NEXT LDT). This effectively decreased the keeper tube area exposed to the ion beam, as well as reduced the overall ion flux to the surface. Furthermore, the flight design of the keeper incorporates a tube wall that is 50% thicker than what was tested in the NEXT LDT. This change, coupled with the reduced erosion rates observed during the NEXT LDT, indicates that keeper wear through should not be a life limiter for the thruster.

Figure 14. Extent of erosion of the beam-side of the keeper tube wall as a function of upstream axial distance. The location of the upstream surface of the orifice plate is provided for reference.

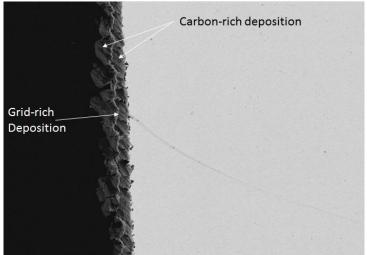
Figure 15. Backscattered electron photomicrograph of the deposition layer on the beam side of the neutralizer keeper. A thin layer of gridrich deposition was found within the primarily carbon-rich layer that had originated from the facility.

with a higher degree of accelerator grid aperture erosion and a lower facility backsputter rate. While this deposition is not expected to cause any issues, it indicates that the keeper tube surface facing the beam will likely collect deposition from the grid in flight.

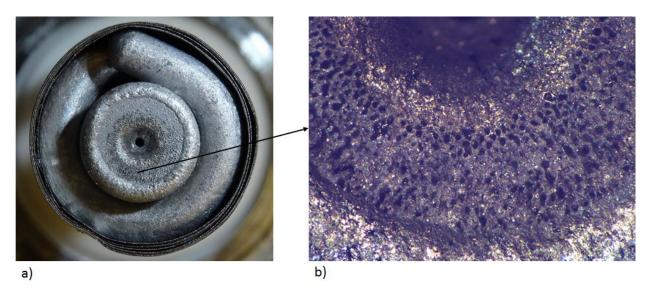
After the keeper was removed from the NCA, the cathode orifice plate and tube were visually inspected. Texturing of the orifice plate was observed, especially on the side closer to the ion beam. A closer inspection of this surface revealed the texturing to be pitting on much of the surface exposed by the keeper orifice plate (see Figs. 16 and 17). The photomicrograph shown in Fig. 17 also shows signs of surface melting in the vicinity of the pits, which is another indication that perhaps arcing had occurred to the orifice plate. The weld between the orifice plate and cathode tube was found to be intact. Inspection of previously tested neutralizers with NEXT, including both engineering model and prototype model hardware, have also shown signs of pitting and/or arcing, although not as extensive as what is observed in the NEXT LDT. It is unclear at this time whether such pitting was observed on the neutralizer tested in the NSTAR ELT.

Figure 16. Photographs of the neutralizer cathode orifice plate with keeper removed. a) Overall front view of the orifice plate, showing signs of texturing. The side closer to the ion beam is at the bottom. B) Close-up view of texturing, revealing numerous tiny pits in the surface.

It is speculated that this arcing had occurred during thruster recycles. During a recycle, it was found that the accelerator grid reaches potentials as high as the beam voltage. Large currents were also measured during a recycle as the beam power supply output capacitor discharged. These currents were found not only through the accelerator grid line, but also through the neutralizer common line leading back to the beam power supply. This indicates that a current path exists from the accelerator grid to the neutralizer as the beam power supply capacitor discharges during a recycle. Furthermore, visual observations of recycles occurring during the LDT around 30 kh revealed sparks occurring in the vicinity of the accelerator grid while the neutralizer plume became very bright and expanded. Depending on the size of this current and how it is carried, there may be ablation or arcing on the cathode orifice plate. While this was an unexpected observation, this arcing and resulting pitting did not prevent thruster
